Post-flight review (17.12.2023)

Telemetry Data Analysis of High-Altitude Balloon Flight on 16.12.2023

This telemetry data analysis focuses on a high-altitude balloon flight which took place on the 16.12.2023. The flight aimed to test the RTU HPR Racoon launch platform, with an emphasis on the overall performance of all systems. The experiment integrated two critical onboard systems, namely the Balloon Flight Computer (BFC) and the Payload Flight Computer (PFC). This report includes analysis of the only available flight telemetry data, generated by the PFC, as the BFC did not record any telemetry data. The report also includes information about the Balloon tracking system (Rotator) performance. The analysis includes an examination of general flight information and an investigation of anomalies encountered during the mission. The report examines the root causes of these anomalies, providing an understanding of their origins and proposing solutions for possible problem rectification.

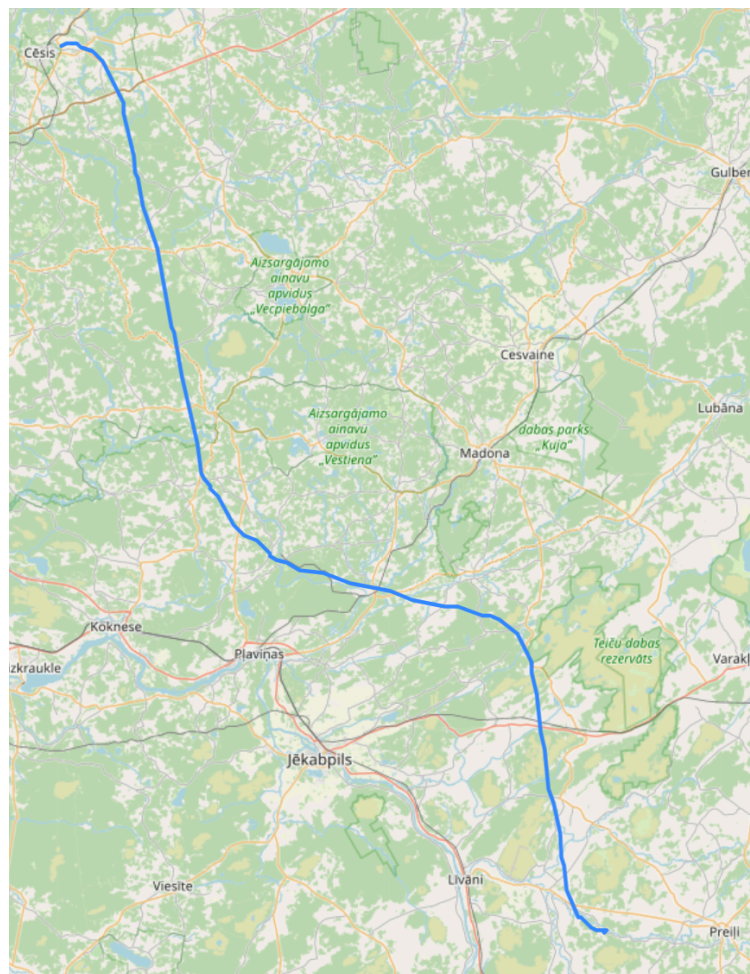
Flight trajectory [1]

The balloon's trajectory, originated from Cēsis airfield (57.321031, 25.321915) and concluded approximately 15,5 kilometers west of Preiļi (56.293298, 26.477513), 134,5 km away from the launch place. The flight ended with a landing in a tree, approximately 10 meters above the ground. See figures [1][2][3].

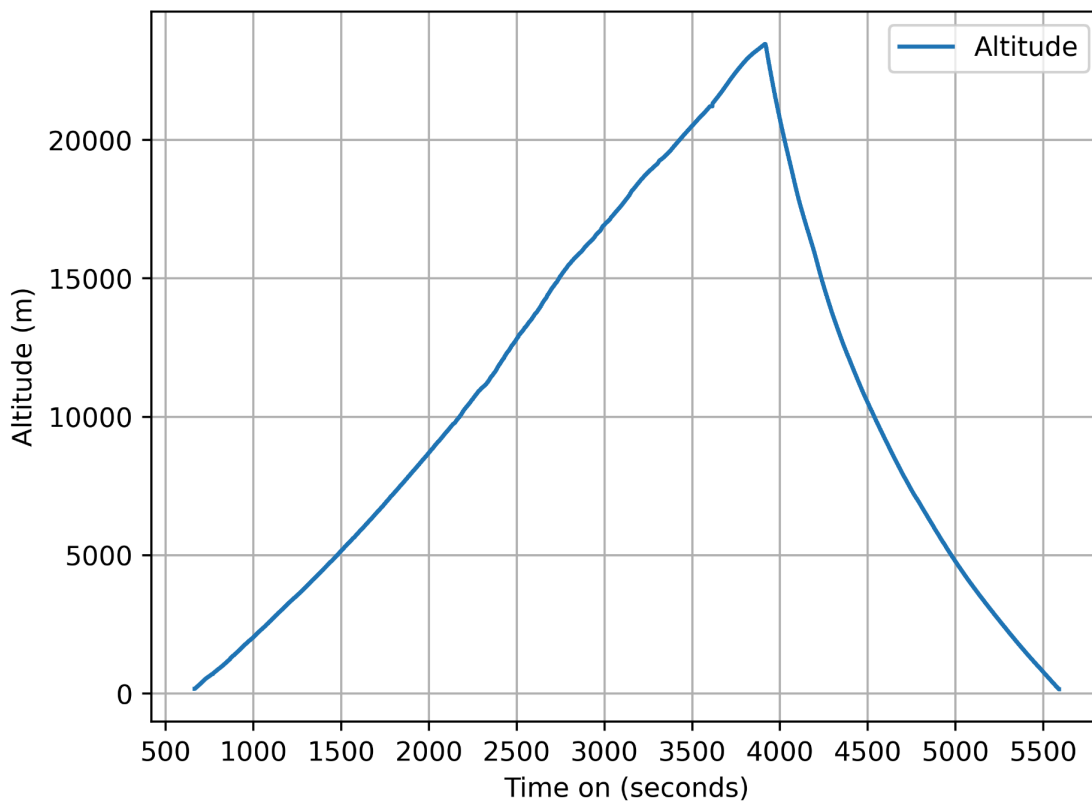
GPS altitude during flight [3]

The maximum GPS altitude achieved was recorded at 23,47 kilometers, while the barometer altitude reached only 4,19 kilometers. The ascent phase increasing ascent speeds, with the balloon ascending at an average speed of 5,94 m/s from 175 meters to 5000 meters, up to an average speed of 7,22 m/s from 15000 meters to the maximum altitude of 23472 meters. During the descent, the balloon exhibited a rapid descent rate, descending from 23472 meters to 15000 meters at an average speed of -26.35 m/s. The balloon slowed significantly at lower altitudes, down to around -7 m/s from 1000 m to 300 m. The balloon landed at around -6.8 m/s.

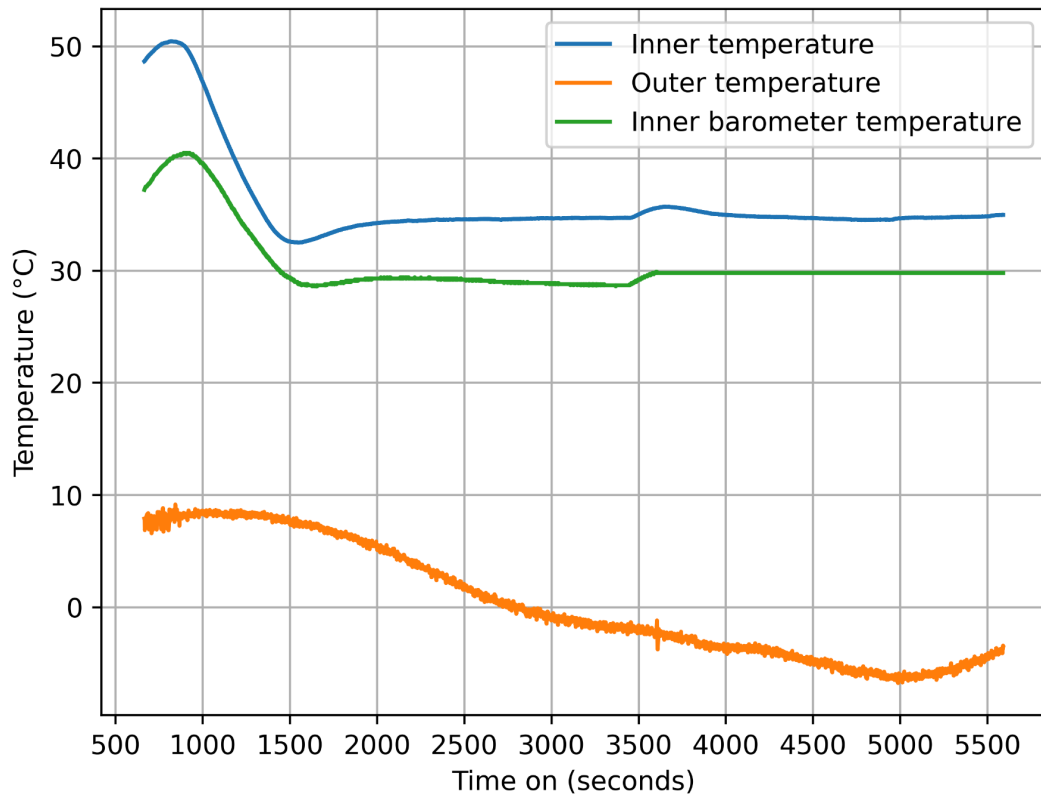
Inner and outer temperature readings during flight [4]

The temperature inside the enclosure housing the onboard computers exhibited a notable variation throughout the mission. Starting at approximately 3 degrees, the temperature increased to 8,5 degrees before launch. During the ascent phase, the

internal temperature dropped to around -2 degrees, reaching its lowest point of -6 degrees towards the end of descent. Subsequently, as the balloon had landed, the temperature gradually increased, reaching almost 14 degrees before the system was powered down. See figures [4][5].

Within the payload container, two temperature sensors were used, including a dedicated temperature probe and a temperature sensor integrated into a barometer. The latter consistently recorded lower temperatures, with an initial difference of up to 10 degrees, which later stabilized to around a 5 degree difference during the flight. See figure [4].

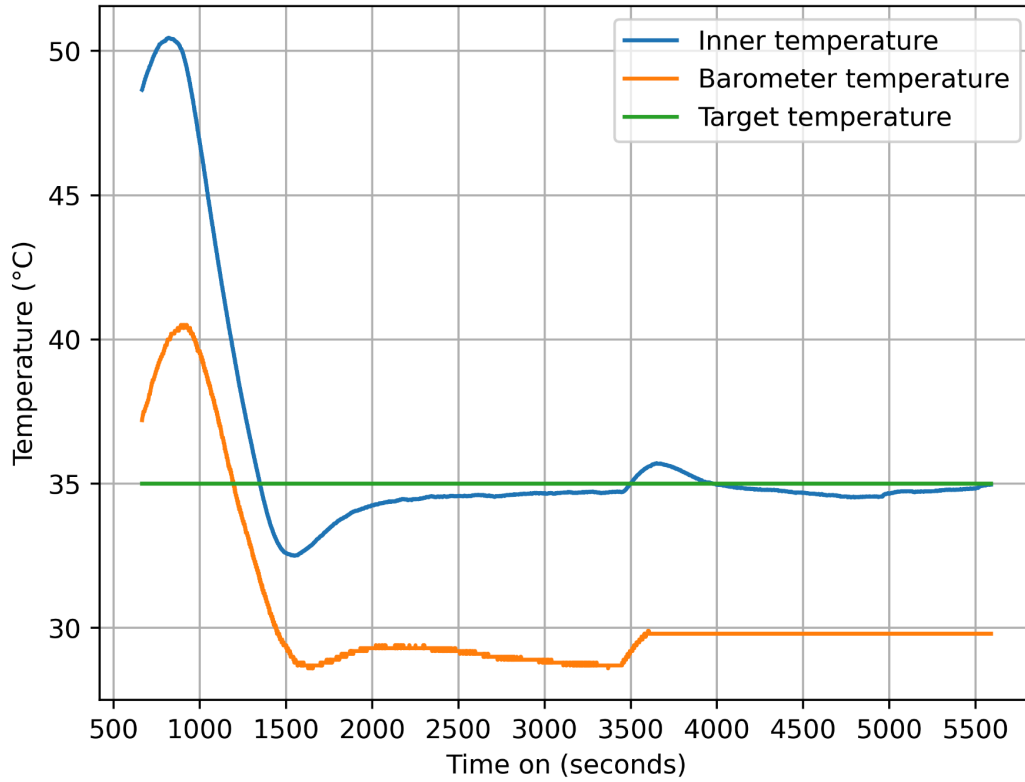
Inner temperature probe and inner barometer temperature vs the target temperature during flight [6]

The payload container, equipped with a PID controlled heating element, aimed to maintain a stable temperature of 35 degrees. Upon activation, the heating element quickly elevated the temperature to 50 degrees, generating a maximum of 4 watts of heat. After cooling down to the target temperature, the system sustained a consistent temperature around 35 degrees, with minimal fluctuations of approximately 0,2 degrees higher or lower. The power to sustain the stable temperature during the flight was just under 1 watt, decrrequired easing to approximately 0,6 watts after landing. See figures [6][7][8][9].

Notably, the payload container temperature was not kept at a consistent 35 degree temperature. The initial spike to over 50 degrees is not acceptable and would have failed the payload experiment before it even began. The issue is related to the heating system PID loop, which was not extensively tested with low temperatures. The heating system also saw significant changes to the heater control system, with the used MOSFET being changed, which invalidated the previously calibrated PID values. Although, once the target temperature was reached, the temperature was kept consistent, which shows that the PID system works in certain conditions, with only the initial heating needing significant improvements.

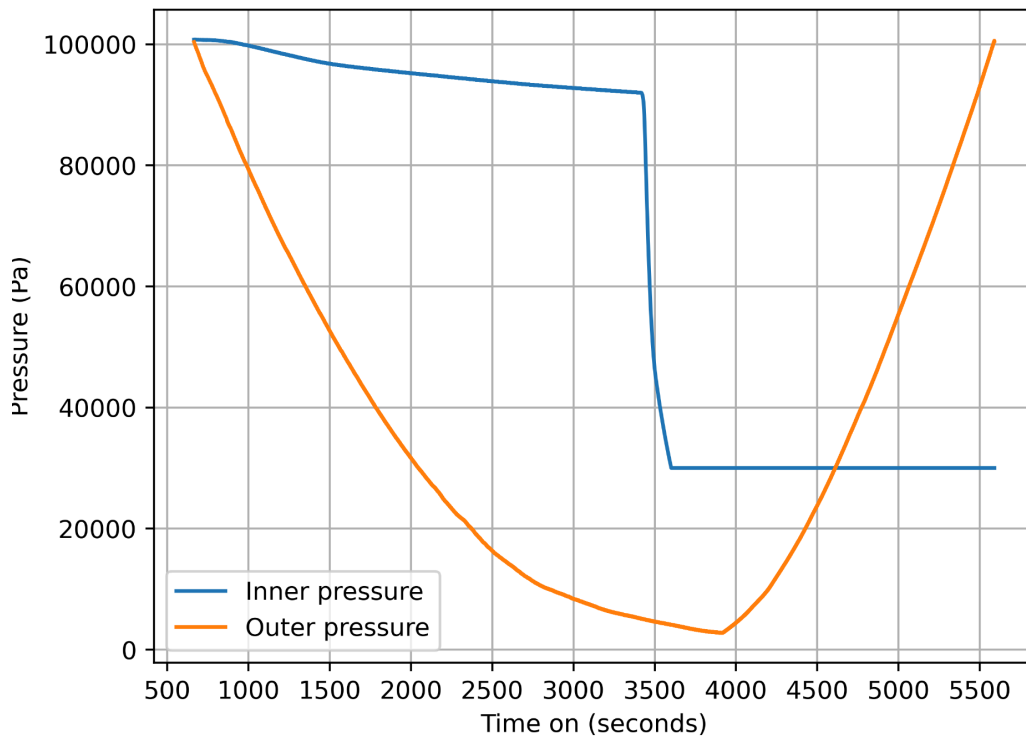
Inner and outer pressure during flight [10]

The hermetically sealed payload container maintained an initial internal pressure lower than the external pressure, measured at approximately 95640 Pa. During the ascent phase, the pressure inside the container decreased at a slower rate, approximately 6 Pa per second, compared to the external pressure drop of around 50 Pa per second. However, at an altitude of approximately 19.9 km, a rapid leak in the seal occurred, leading to a substantial increase in the rate of pressure loss to 700 Pa per second. The internal pressure plummeted to 30 kPa at an altitude of 21,2 km, at which point the pressure sensor stopped providing readings due to a software related issue. See figure [10].

Another significant issue encountered was the pressure sensor inside the payload container being flagged as failed, because of low pressure inside the container, caused by a leak between the container itself and the container lid. The sensor failure detection system was initially implemented to reduce the chance of full system failure, if a single sensor failed. The failure detection system looks at two parameters - how long it takes to read the data, and if the measured value is outside the expected range. In this case, the leak caused low pressures to be recorded. As the pressure fell below the set limit, the system thought that the sensor had failed, and flagged it as failed, which meant that no further data was read. This issue meant that no data further data was read, and it is impossible to know at what altitude the leak stopped. The next day, after taking the SD card out of the PFC, the system was turned back on, and telemetry readings were transmitted. This showed that the pressure inside the payload container was around 88 kPa. This means that the leak must have stopped at some point during descent.

The payload container seal failure shows that a new container has to be designed before the payload experiment is flown, as during development and this flight, issues with hermetically sealing the container have been encountered.

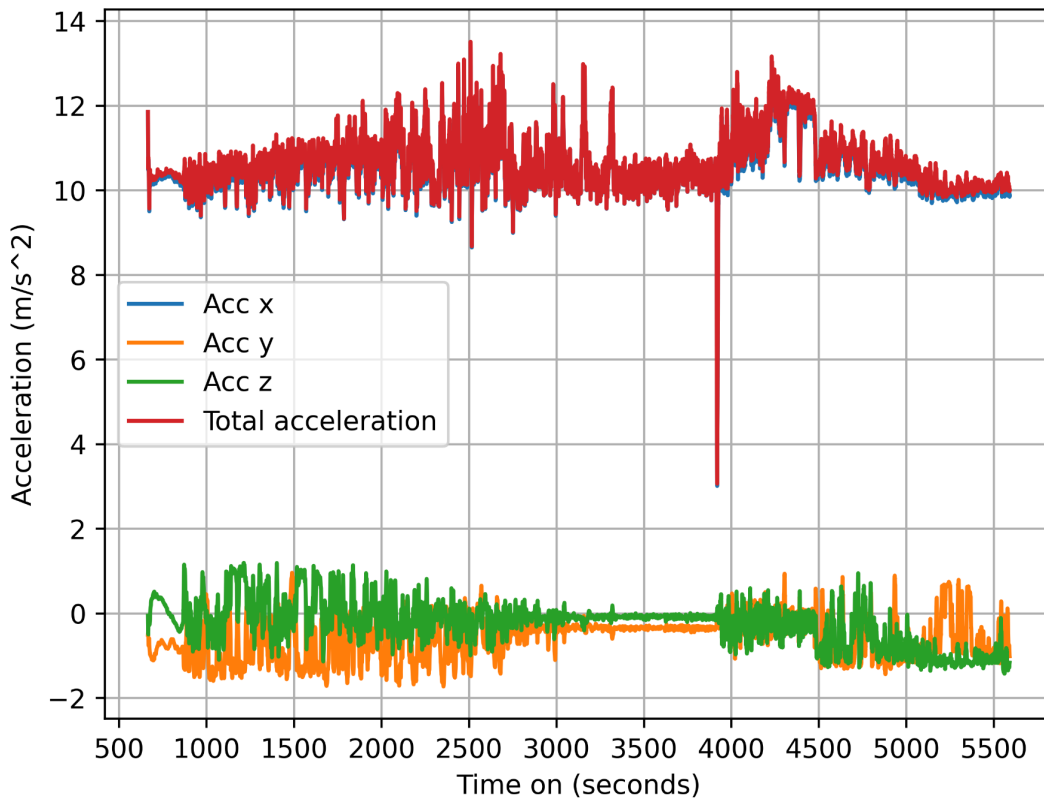
Acceleration values during flight [11]

Throughout the ascent, the balloon exhibited slight acceleration variations, although no significant deviations were observed. The ascent phase was characterized by a rough trajectory, marked by fluctuating acceleration and rotation values across all axes.

During the descent phase, the balloon did not experience free fall, and the lowest recorded acceleration was only around 3 m/s^2 .

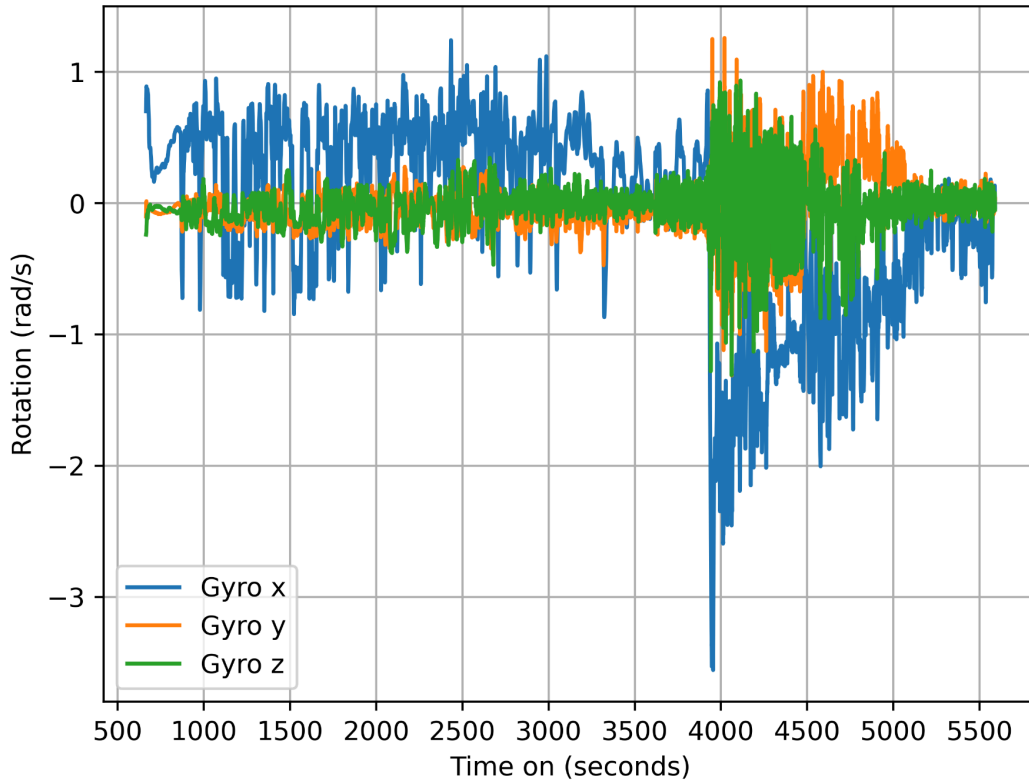
Gyro values during flight [12]

In the upper atmosphere, severe rotation was observed, with consistent and inverting rotations of 1 rad/s on the y and z axes and a -2 rad/s rotation on the x-axis. As the balloon descended, the rotations gradually decreased in severity. See figures [11][12].

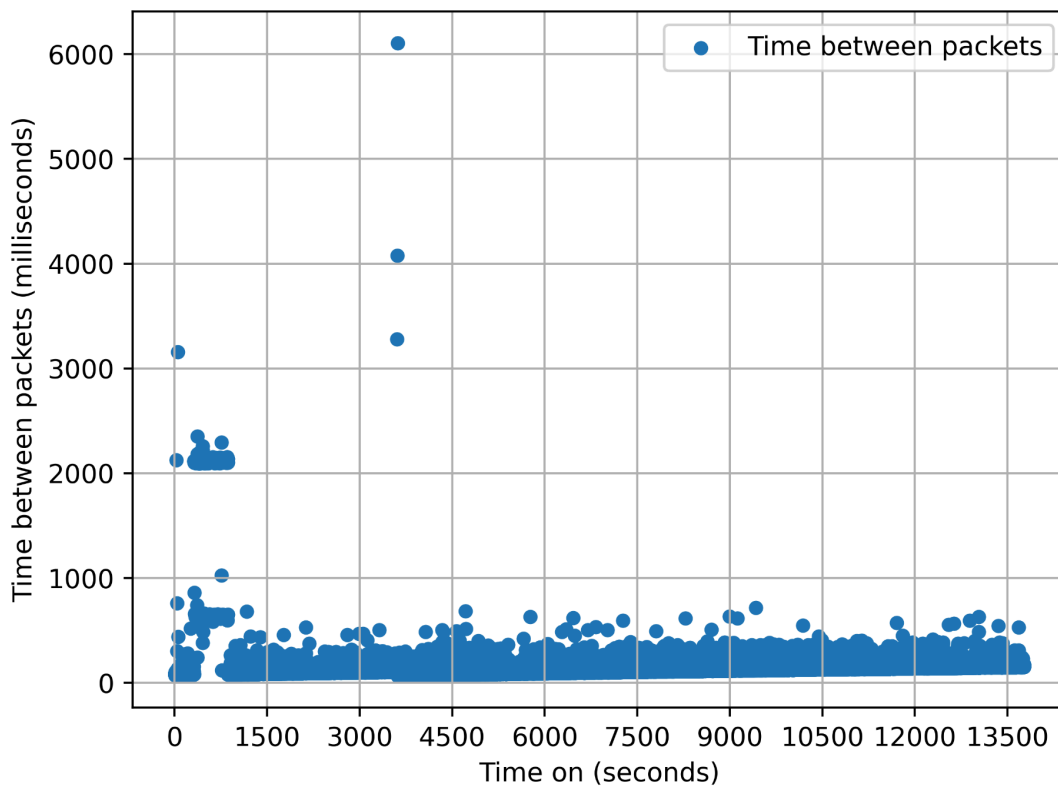
Time between logged telemetry packets [13]

The median time between packets was observed to be 110 milliseconds, indicating a generally consistent telemetry data logging rate. However, anomalies were identified in the telemetry message intervals, with both extreme values and patterns of delays.

The time between messages range from 66 milliseconds (minimum time between packets) to 6105 milliseconds (maximum time between packets). There are 376 extreme delay values, where the time between packets was at least 4 times larger than the average. Specific instances of these occurrences include delays of 2126 ms and 3156 ms shortly after turning on, as well as 339 occurrences of alternating 2100 ms and 640 ms delays between packets. This pattern persisted from 314 seconds after being turned on until approximately 866 seconds after activation. Additional occurrences of delays around 500 ms were scattered throughout the entire timeframe. See figures [13][14].

The identified extreme anomalies can be attributed to software-related issues associated with the heating system and payload container pressure readings. Initial anomalies, following power-up, are linked to commands for turning on the heating system and transitioning into ascent mode. While suboptimal, these anomalies are non-critical due to the inherent sluggishness of these processes, caused by the non-optimised nature of the used software.

The subsequent 339 occurrences of delays are attributed to a software bug in the heating system, triggered by significant differences between inner temperature sensors. This led to unintended radio transmissions, initially intended for logging only. The three large occurrences of delays towards the end of the flight resulted from a similar issue related to payload container pressure readings. The low pressure values due to the experienced pressure leak, triggered the sensor failure detection system, which resulted in the sensor being disabled, and error messages being sent over radio, which were intended for logging purposes only.

The last notable issue encountered is related to the inconsistencies in the delay between logged telemetry packets. This issue was mainly caused by the logging system itself and improperly configured info and error message logging, as no info or error message should have been transmitted over radio. Although, this is not the only issue, and there are most definitely other underlying issues related to the logging system, as transmitting messages is a non-blocking function, and such long delays between logged telemetry packets should not have been experienced.

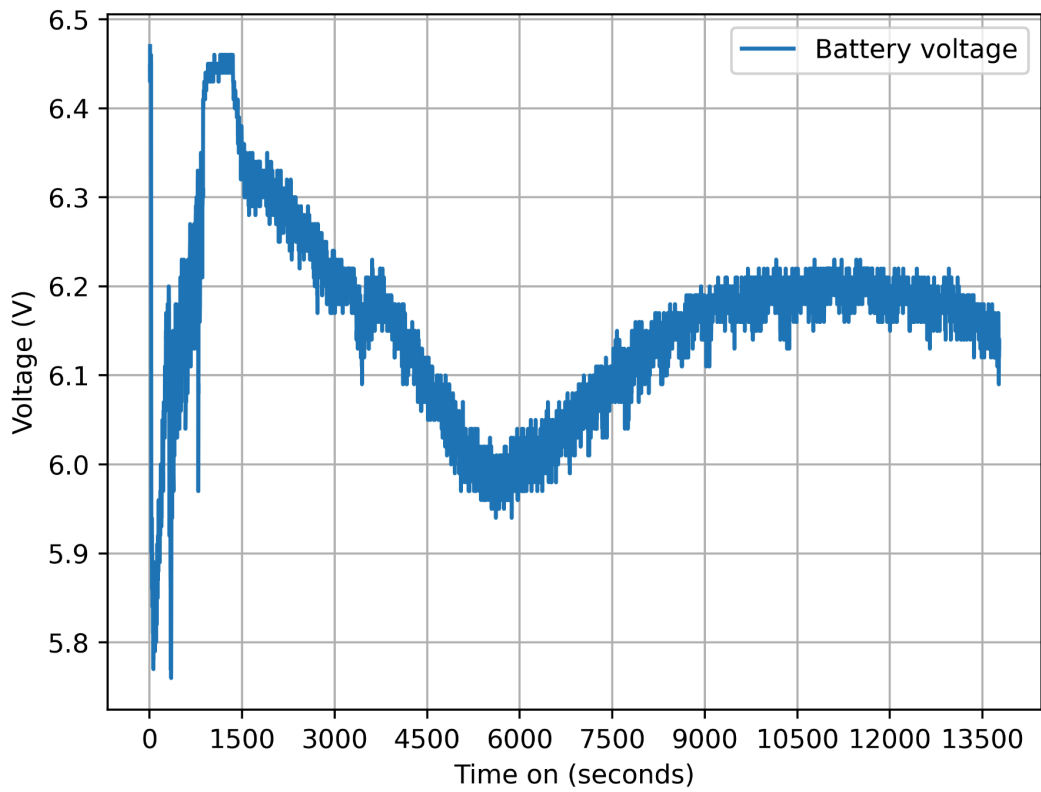
Battery voltage [15]

The battery voltage started at approximately 6,46 volts, suggesting an initial state of charge (SOC) of around 30% [16]. However, given that all batteries were fully charged before launch, this deviation is likely attributable to the challenges in accurately estimating SOC at low temperatures.

During the initial heating system startup, the battery voltage experienced a slight dip below 5,8 volts due to the substantial current draw required for heating the payload container. As the heating process slowed, the voltage returned to the initial levels, but gradually decreased as the internal temperature of the system declined. The lowest recorded voltage was 5,95 volts.

After landing, the battery voltage showed a slow and steady increase, reaching a peak of around 6,18 volts. Subsequently, it began decreasing, possibly influenced by the battery voltage declining as the SOC decreased. The final voltage was approximately 6,15 volts, before the system was powered off. See figure [15].

The observed battery performance indicates that the current setup has more than sufficient battery capacity, with the potential for the entire system to operate for several additional hours. Moreover, it highlights the challenge of relying on SOC tables for accurate assessments of battery state at low temperatures, and the significant impact of sub-zero temperatures on voltage levels.
