Post-flight review (17.12.2023)

Telemetry Data Analysis of High-Altitude Balloon Flight on 16.12.2023

This telemetry data analysis focuses on a high-altitude balloon flight which took place on the 16.12.2023. The flight aimed to test the RTU HPR Racoon launch platform, with an emphasis on the overall performance of all systems. The experiment integrated two critical onboard systems, namely the Balloon Flight Computer (BFC) and the Payload Flight Computer (PFC). This report includes analysis of the only available flight telemetry data, generated by the PFC, as the BFC did not record any telemetry data. The report also includes information about the Balloon tracking system (Rotator) performance. The analysis includes an examination of general flight information and an investigation of anomalies encountered during the mission. The report examines the root causes of these anomalies, providing an understanding of their origins and proposing solutions for possible problem rectification.

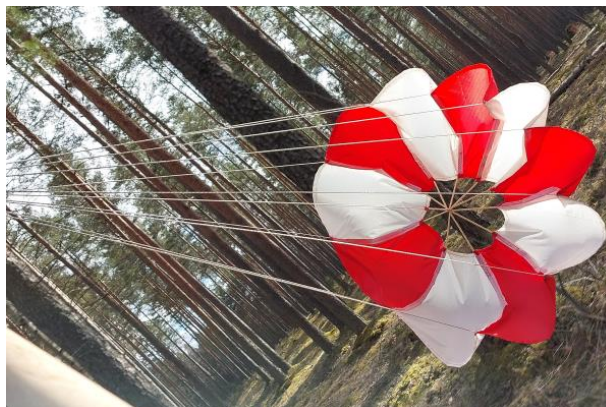
Tiek veikts pieņēmums, ka

$$Cd_{kaste} = 1; A_{kaste} = 0.065 \text{ m}^2$$

$$mg = F_1 + F_2$$

$$m \cdot g = \frac{Cd_{izpletnis} \cdot \rho \cdot v^2 \cdot A_{izpletnis}}{2} + \frac{Cd_{kaste} \cdot \rho \cdot v^2 \cdot A_{kaste}}{2}$$

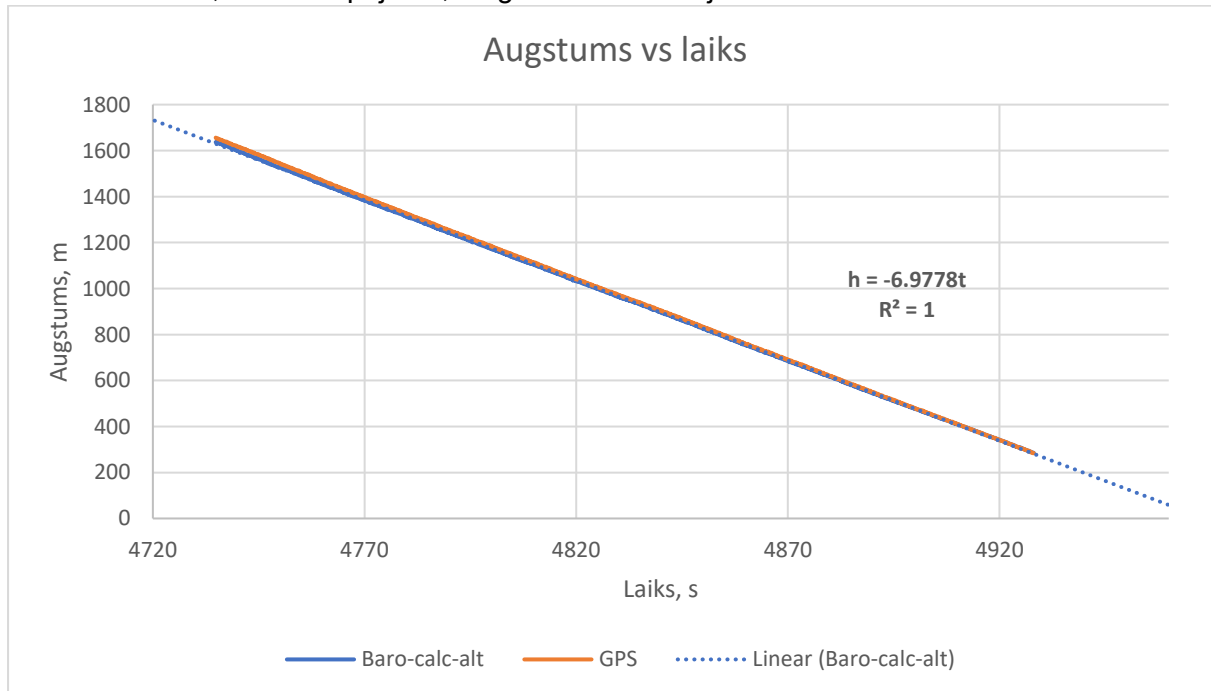
Reālais krišanas ātrums:

Veicot datu apstrādi tika iegūts, ka krišanas ātrums piezemēšanās brīdī ir bijis $6.98 \frac{\text{m}}{\text{s}^2}$.

Nemot vērā, ka reālās dzīves apstākļi visdrīzāk atšķirās no aprēķinos izmantotajām vērtībām, tad šāda maza kļūda ir pieņemama. Visdrīzāk Kastes radītā berze ir bijusi nedaudz lielāka, kā arī iespējams, ka gaisa blīvums bijis nedaudz lielāks.
